1928 Durant Model D75 Differential unit rebuild and upgrade

By: Steven Blomquist

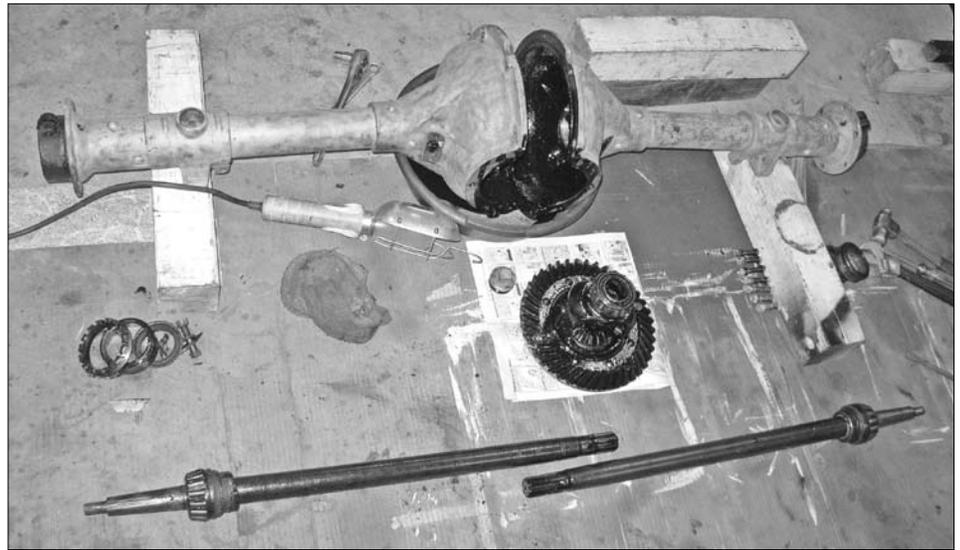
As I worked through the task of the disassembly, I found a safe area in the garage to lay out the various parts of the differential unit in the order they came apart so there was no ambiguity as to how they would fit back together.

I borrowed a camera to give me assurance that upon reassembly the details could be viewed as to where the parts previously fit together.

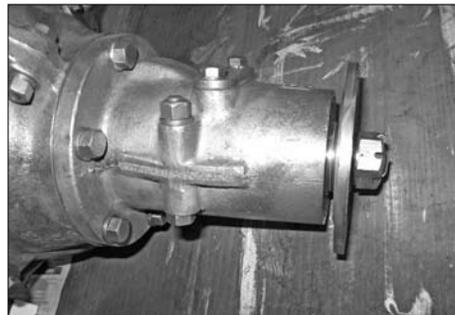
section of the pinion housing to clamp the adjustment ring securely in place. After removing the locking bolt and turning out the shaft adjustment ring, the pinion shaft with its bearings were able to be removed from the large open end of the housing. The parts for this assembly were initially inspected for wear and condition and set aside for later cleaning and inspection. The photo below shows the pinion housing

assembly in place just before painting the unit.

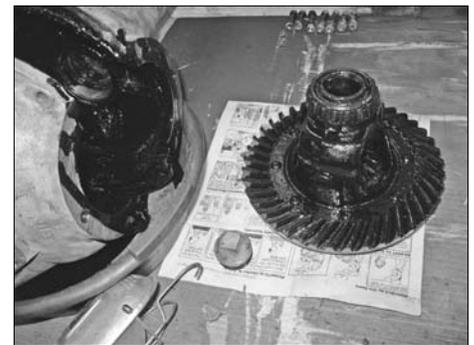
The axle housing assembly has seven bolts that hold the two casted halves together. Once the axle housing is apart, the carrier unit within the axle housing was removed from the axle shafts and set on a suitable work area. It was disassembled further by removing the locking bolt and shaft that secures the spider gears and thrust washers in place. After initial inspection the carrier unit with the parts was set aside for later cleaning and inspection.

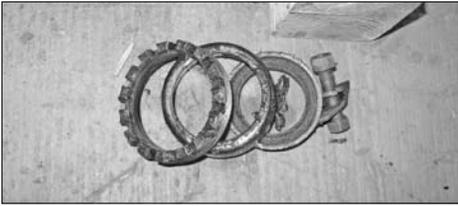
Each wheel end of the axle housing has a large threaded adjustment ring that is clamped by a locking bolt and locking pawl that couples into one of the adjustment notches on the ring. They were disassembled to allow the axles to be taken out from their respective housing sections. The photo below shows the layout of the original axle seal, adjustment nut, axle bearing outer race, and locking bolt.

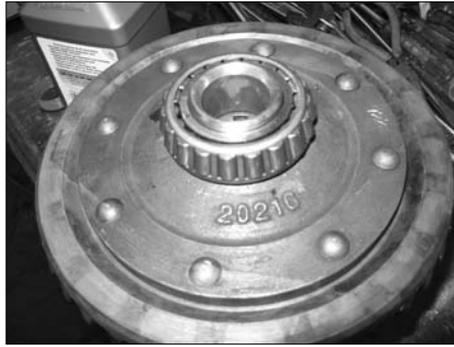
Donning a pair of latex mechanics gloves, I began the task of cleaning the eighty plus years of crud and grime from the parts and housings using solvents and then blowing them off using compressed air. I used a flat file on all the flat mating gasket surfaces to eliminate any nicks and burrs on the surfaces for later fitting and sealing. After thorough inspection of all the parts for the differential unit I found most of them in relatively good condition for their age. One of the carrier unit tapered roller bearings was found to be in bad shape and needed to be replaced. After some research and visits with other Durant club members, I found the original tapered roller bearings obsolete and the "new old stock" no longer available. Further investigations led me to find modern tapered roller bearings of the same outside and inside dimensions as the originals but with a wider installed bearing width of sixty two thousandths of an inch. I decided this would be a perfect opportunity to replace both the old bearings with the modern ones and have a big margin of assurance against any future bearing issues. The next photo shows the carrier unit with the modern tapered roller bearings in place.

In order to use these new bearing sets, I compensated for the difference in width by machining sixty thousandths of an inch off the face of each of the carrier adjustment rings where they mate with the outer bearing races. This machining allowed the unit to have an adjustment of the same range and overall assembled width as the original setup. This modification was an easy decision to make as

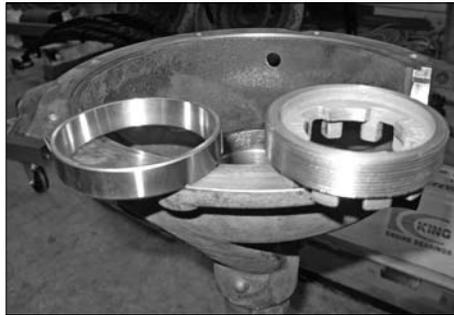
the original tapered roller bearings were no longer available and the new replacements were of a more robust design. The next photo was taken of the width modified adjustment ring and outer bearing race prior to the assembly.

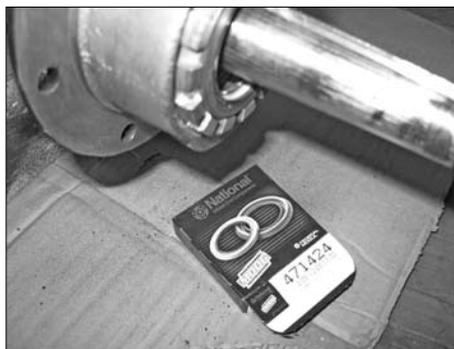
Another challenge was to investigate the possibility of replacing all the original seals with modern ones so the differential unit would not leak using modern day gear oil. The original axle seals installed in the axle adjustment rings at the brake backing plate locations were fairly easy to accommodate with modern day ones. I found the modern National brand neoprene seals with a part number of 471424 that have the same inside diameter and width as the originals but have a slightly larger outside diameter.

To solve this issue, I machined the inside diameter of the axle adjustment rings slightly larger where the new standard seals would press into the ring bores. The photo shows the new seal in

place during the final assembly of the axle adjustment ring.

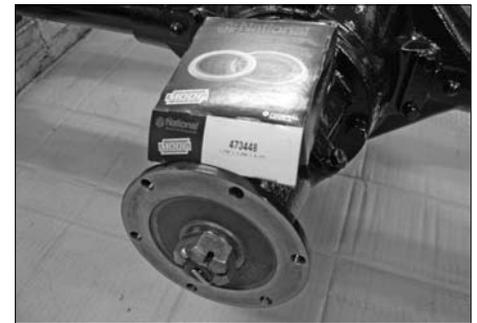
The pinion shaft seal used required a little more thought as the shaft sealing diameter and the housing bore seal diameter were not of the standard modern day sizes. I machined the pinion housing seal bore slightly larger and to a depth to receive this new seal. This allowed a National brand modern day seal with a part number of 473448 to be pressed into the housing bore to the correct depth. For the inside diameter sealing surface, I machined a steel sleeve of the right length having the correct sealing diameter for the new seal. It was press fit onto the driveshaft flange hub seal surface which allowed the new seal inside diameter to seal the unit. The photo below was taken after painting the final differential assembly and shows the seal part number used.

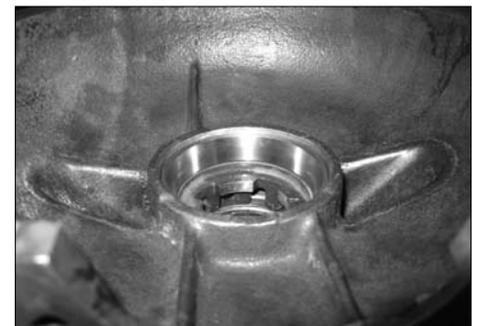
The first process in reassembly after cleaning the differential unit was to put together the carrier unit. It was assembled in the reverse order by first installing the spider gears, thrust washers, and pressing the new tapered roller bearings with the Timken part number of 30209A in place. Next was to install the carrier adjustment rings and the tapered roller bearing outer races in their respective positions. The adjustment rings should turn freely throughout the adjustment range and the races should slide in the bores having a snug fit.

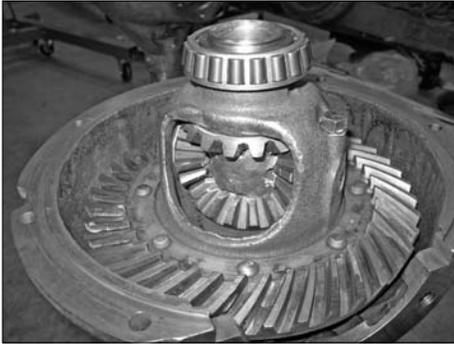
The easiest way to continue with the next step of assembly is to support the driver's side half of the axle housing in the vertical position as shown and then set the carrier unit into the bearing race. Be certain the carrier unit is positioned with the ring gear teeth facing the correct side otherwise the axles will rotate in the wrong direction with respect to the pinion gear rotation.

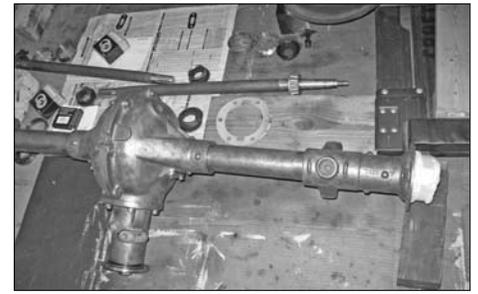
for proper mesh with the ring gear a little later in the assembly process. Install the pinion shaft housing along with the proper thickness gasket and torque the bolts to the proper specifications. Because of the split differential design, any adjustments will have to be verified with a dial indicator through the large drain plug hole opening. At this time check that the carrier bearing end play is set by moving the adjustment rings toward each other to attain the proper bearing adjustment. The backlash adjustment is then set to the proper specifications by moving the carrier bearing adjustment rings simultaneously the same number of adjustment notches. The pinion and ring gear mesh contact pattern is checked at this time by painting some white lithium grease on several consecutive ring gear teeth as a visual verification of the mesh contact pattern. If the pattern is not correct and centered within the tooth flanks make the adjustment by adding or rearranging the pinion shaft shims to allow the position of the pinion gear to be the right depth relative to the ring gear. Verify the backlash and end play measurements to correct specifications and check the visual mesh contact pattern again using the same procedures. Once the correct mesh contact pattern and backlash adjustments are achieved the pinion housing assembly is removed and the split axle housing parted to apply gasket sealer or install sealing compound to the housing surfaces. Assemble the axle housings having the sealing compound or gasket installed for the final assembly and torque to specifications. Disassemble the pinion housing assembly, install the pinion shaft seal, assemble the unit with the drive shaft flange and torque the nut to specifications. The pinion housing assembly is mounted with a gasket, bolts, and tightened to specifications. Verify the mesh contact pattern, end play, and backlash adjustments in the final assembly. Install the three locking plates at the adjustment ring locations on the housings using new gaskets to prevent any leaks of the unit. The assembly is now ready to be degreased and prepped for painting.

Install the axles, outer axle bearing races, new seals, and axle adjustment

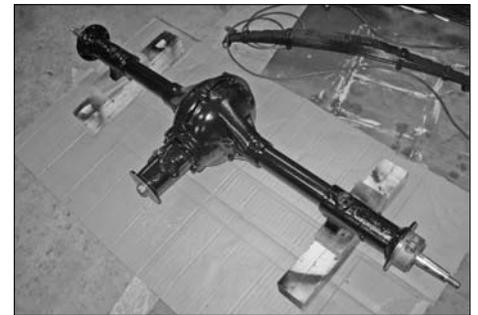
rings into the housing. Follow the adjustment procedures for the bearings to the proper axle end play and lock the adjustment rings after the brake backing plates are in place. As shown in the next photo, the differential assembly is ready to be installed on the vehicle's leaf springs and filled with the modern day gear oil. ❖
